Manhole Inspection Summary

Manhole # S25I__008MH

Insp Date: **3/21/08 12:38 PM**

Location Address: **1047 Hollins St**

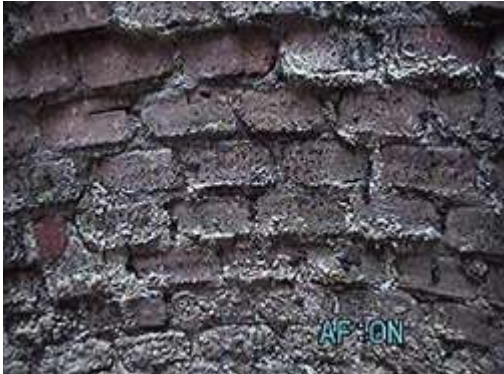
Defect 6

Infiltration: ☐ None ☐ Joint ☐ Cracks ☐ Mortar ☐ Roots ☒ **Wall**

signs of infiltration barrel wall 4-8 oclk area

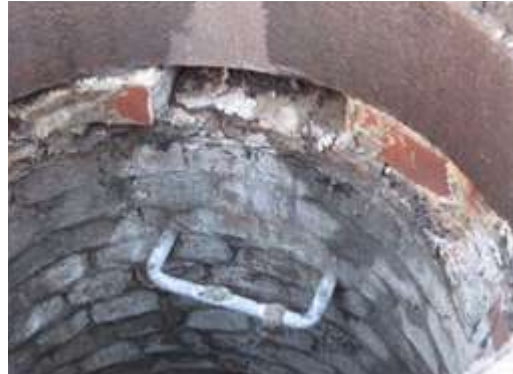
Defect 5

Condition: ☐ Sound ☐ Cracked ☐ Root Intrusion ☒ **Loose Brick** ☒ **Deteriorated**

Infiltration: ☐ None ☒ **Joint** ☐ Cracks ☒ **Mortar** ☐ Roots ☒ **Wall**

chimney missing bricks and mortar & is deteriorated, signs of flow from joint/mortar/wall

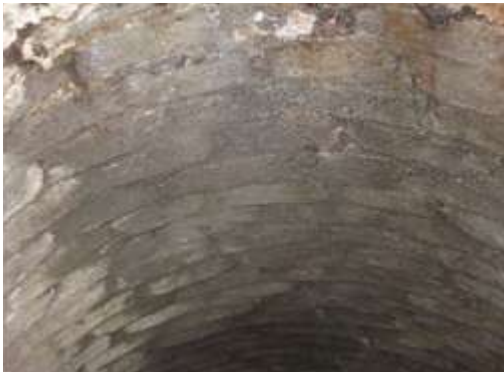
Defect 4

Condition: ☐ Sound ☐ Cracked ☐ Root Intrusion ☐ Loose Brick ☒ **Deteriorated**

Infiltration: ☐ None ☐ Joint ☐ Cracks ☐ Mortar ☐ Roots ☒ **Wall**

corbel deteriorated & shows signs of flow at wall

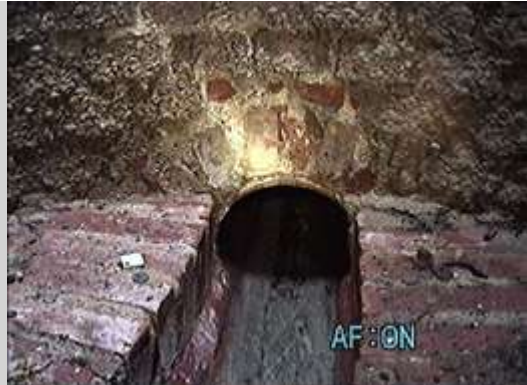
12 O'Clock Outflow

8 in. Circular Gravity Sewer
Pipe Out @ 12 O'Clock

Pipe Height: **8.4** (in.) Rod and Bar (Angled)
Pipe Material: **Clay** ☐ Pipe Lined
Invert Depth: **10.30** (ft.) Flow Characteristics: **Fast**
Deposits: ☒ None ☐ Mud ☐ Sludge ☐ Debris ☐ Grease
Silt Depth: **0** (in.) Deposits Extent:
Infiltration: **None** Pipe Seal Cond: **Sound**

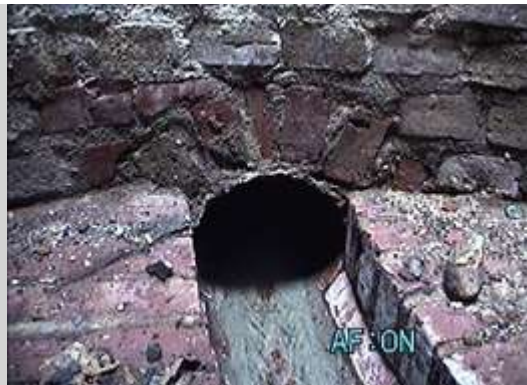
7 O'Clock Inflow

8 in. Circular Gravity Sewer
Pipe In @ 7 O'Clock

Pipe Height: **8.4** (in.) Rod and Bar (Angled)
Pipe Material: **Clay** ☐ Pipe Lined
Invert Depth: **10.35** (ft.) Flow Characteristics: **Fast**
Deposits: ☒ None ☐ Mud ☐ Sludge ☐ Debris ☐ Grease
Silt Depth: **0** (in.) Deposits Extent:
Infiltration: **None** Pipe Seal Cond: **Sound**
